ENGINEERING GEOLOGY ASSESSMENT OF
SLOPE INSTABILITY ON FOREST LANDS
IN SOUTH WESTLAND

A thesis
submitted in partial fulfilment
of the requirements for the Degree
of
Master of Science in Engineering Geology
in the
University of Canterbury
by
MARK J EGGERS

University of Canterbury
1987

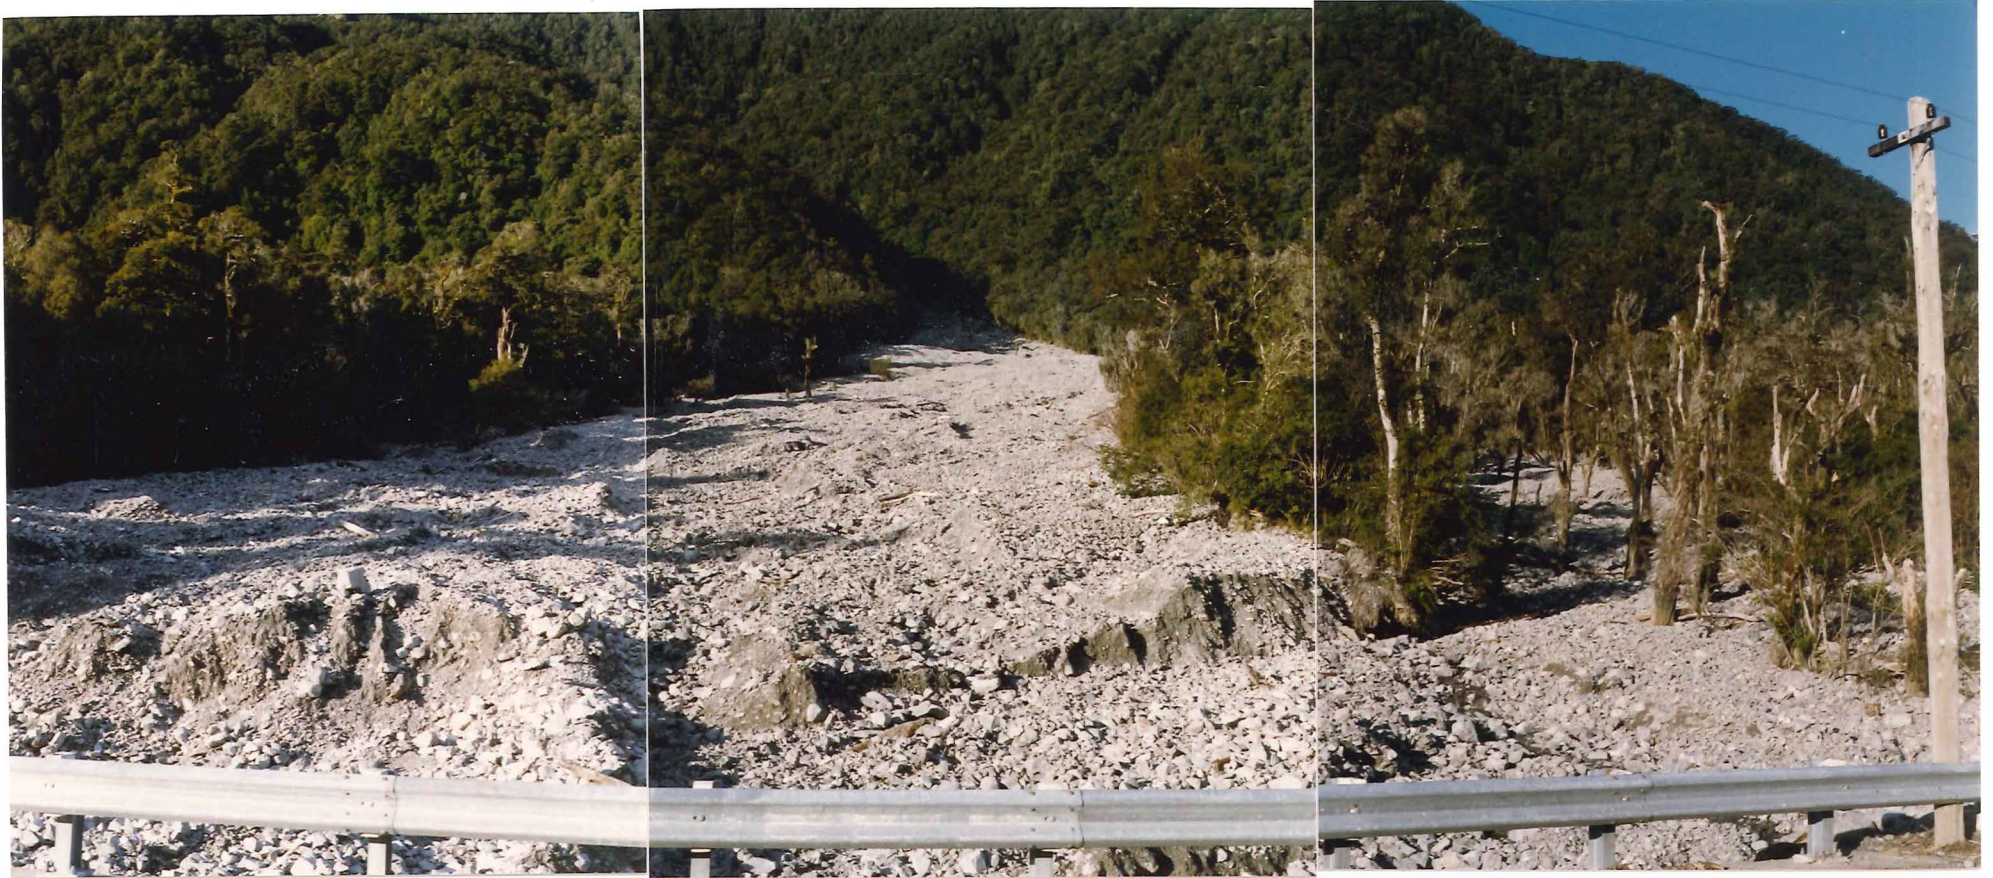
Fig. 4.2 Boulder Creek study catchment showing the outline of the escarpment slope undergoing slope activity. Vertical elevation from the bottom of the photograph to the top of the ridge is approx. 600m. Oblique view looking north-northeast. (N.Z. Geological Survey photo CN 5850a, photographer: D.L. Homer)

The basic morphological feature at Boulder Creek is the distinct convex angular break in slope which marks the boundary between forested stable slopes and bare unstable slopes (Fig. 4.2). The forested slopes are steep, around $36-39^{\circ}$, whilst the area of slope instability forms a deeply incised gully system, which disrupts the otherwise uniform hillside and within which is a complex of slope features and forms.

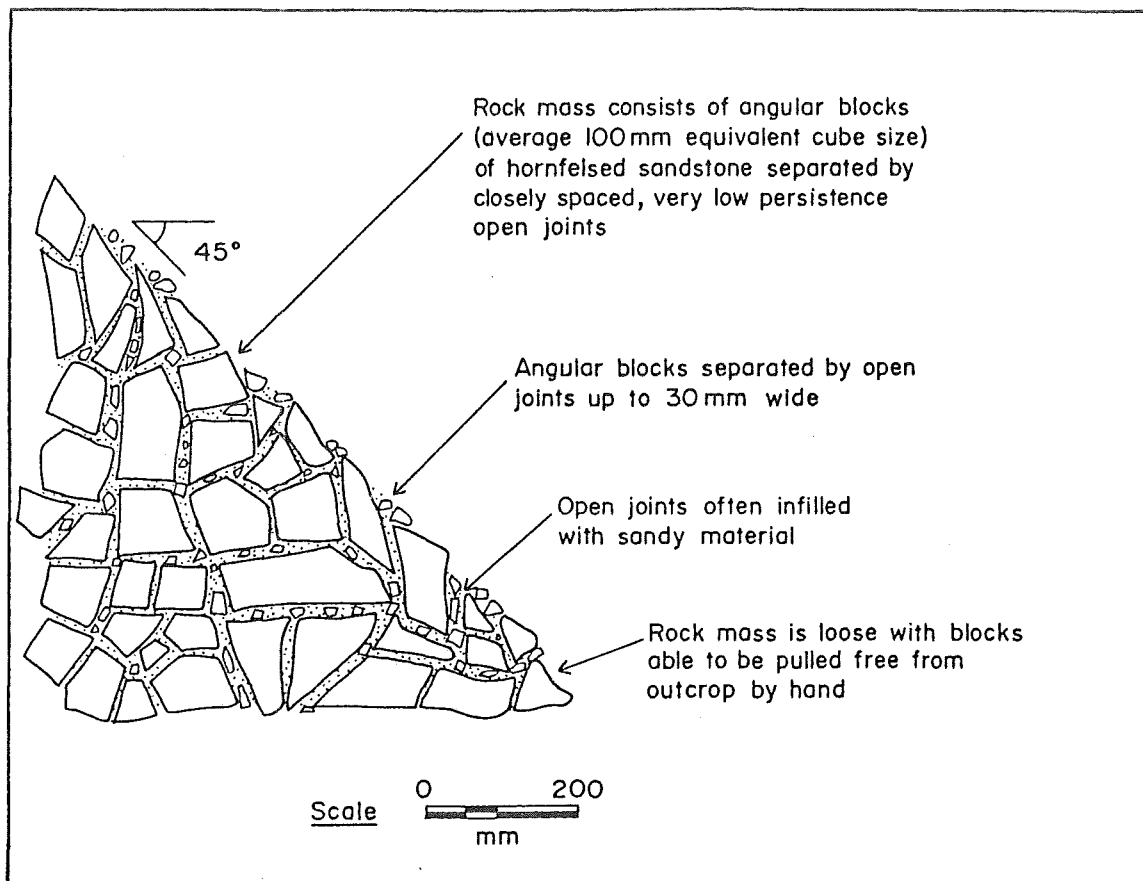
Division of hornfelsed sandstone basement into two sub-units (intact and crushed rock) based on rock mass quality is important in terms of slope movement processes. Table 4.2 compares various rock mass parameters of the intact and crushed hornfelsed sandstone. Intact rock contains moderately spaced, moderately persistent closed joints while crushed rock consists of closely spaced, very low persistence open joints up to 30mm in width and the defects are often infilled with loose granular and coarse sand material (Fig. 4.5). The result is a very loose rock mass consisting of angular blocks up to 500mm equivalent cube size, but generally less than 100 mm, surrounded by a matrix of loose coarse sand.

Fig. 4.5 Sketch diagram illustrating the loose, crushed bedrock mass at Boulder Creek

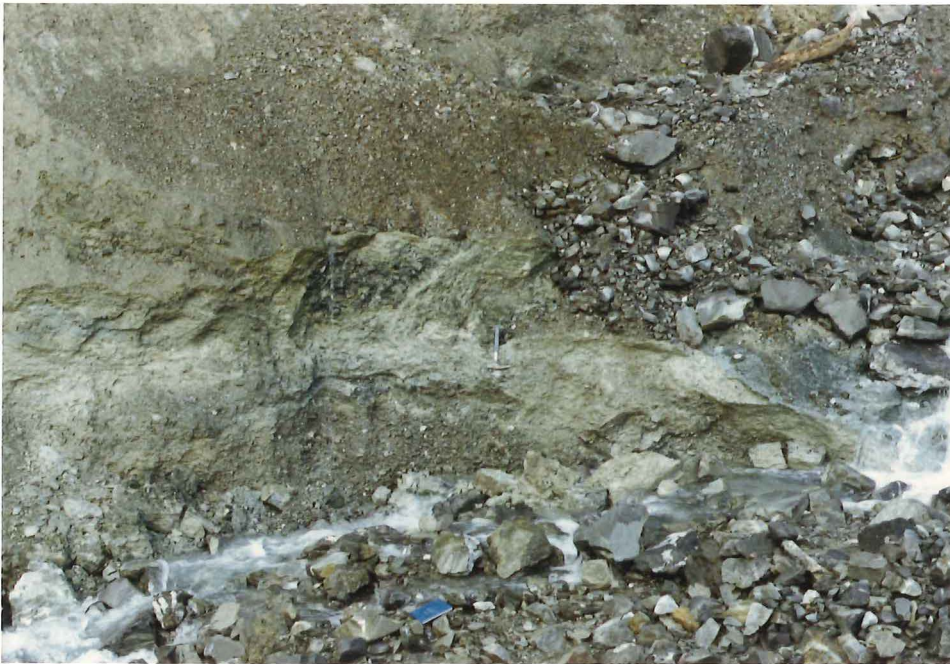
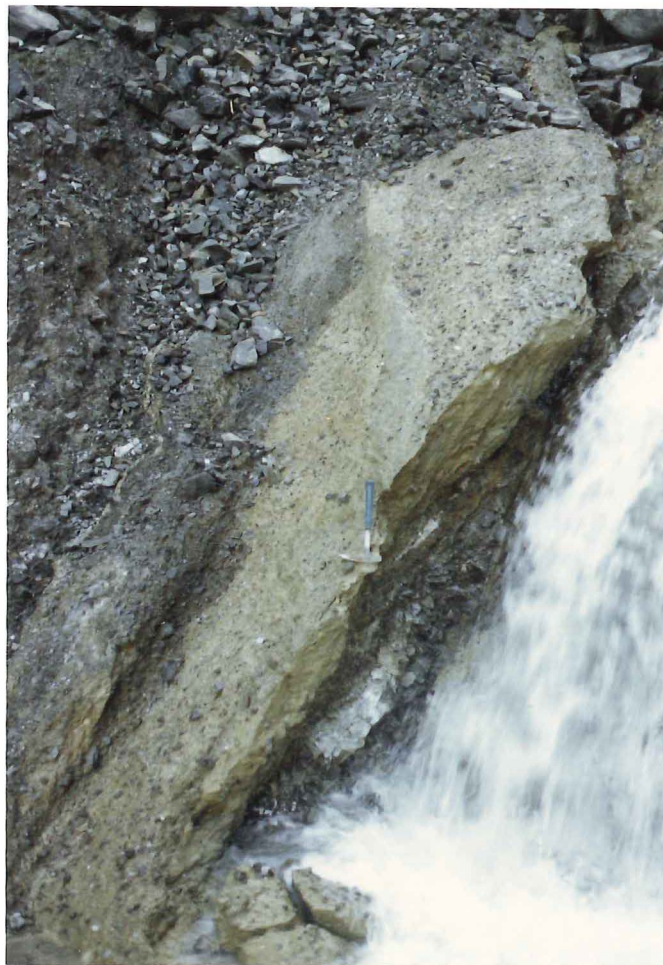
Fault gouge and associated tectonic breccia have been mapped as bedrock units in the Boulder Creek catchment. Fault gouge occurs in zones up to 6.0m wide outcropping mainly in the streambed or in slopes immediately above the streambed (Fig. 4.6). As a consequence exposure is relatively short-lived and changes constantly, only surviving during periods of downcutting by the stream to expose bedrock beneath stream gravels and rock debris alluvium. Fault gouge is dominantly a

Fig. 4.6 Light greyish green and light greenish brown fault gouge material as exposed at localities BE 1 (photo A) and BE 4 (photo B).

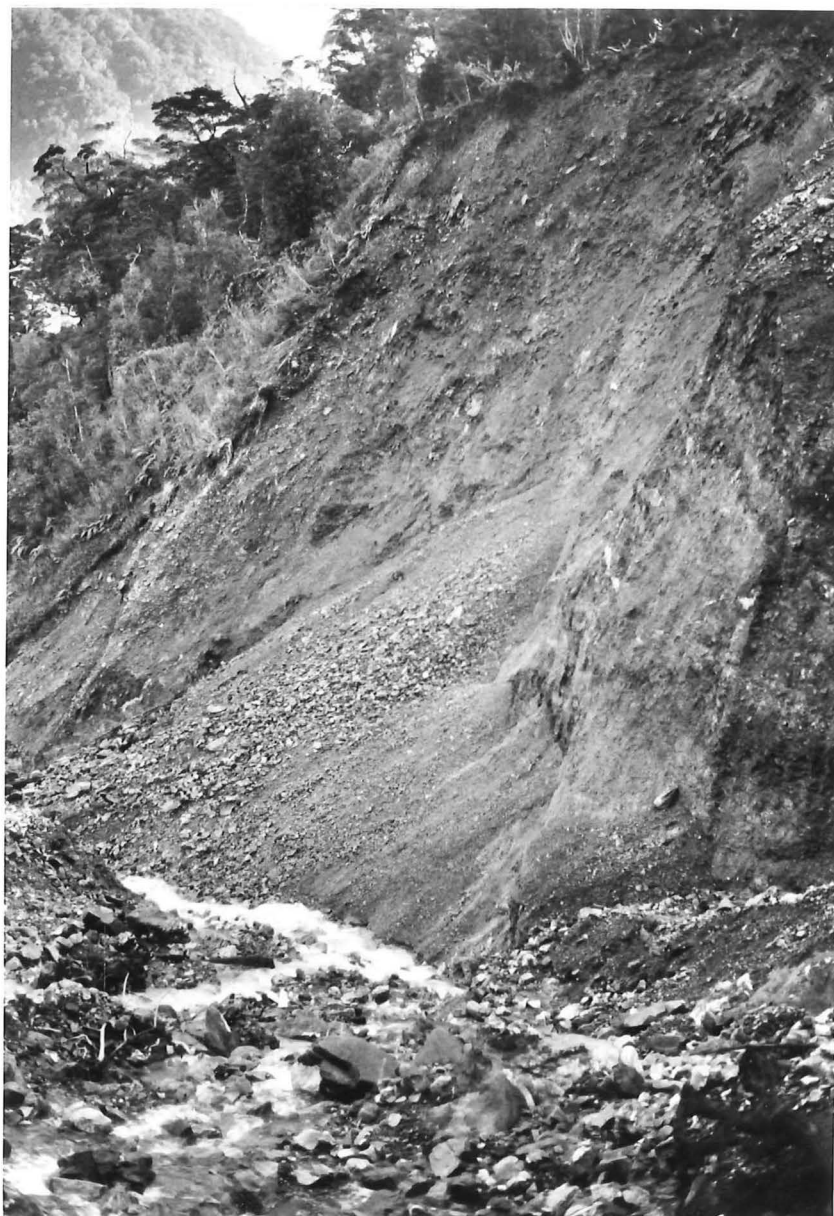
Associated with two southeast dipping fault gouge zones located at BE 1 (Fig. 4.7) and BE 9 is a puggy tectonic breccia extending laterally up to 50m from the gouge zone. This is a weak, light greyish brown breccia comprised of angular, fine to coarse gravel size fragments of bedrock in a matrix of muddy sand. The matrix is moist to wet, hard (to stiff) and easily remoulded on immersion in water.

Fig. 4.7 Puggy tectonic breccia bedrock exposed in approx. 20m high escarpment slope at locality BE 1.

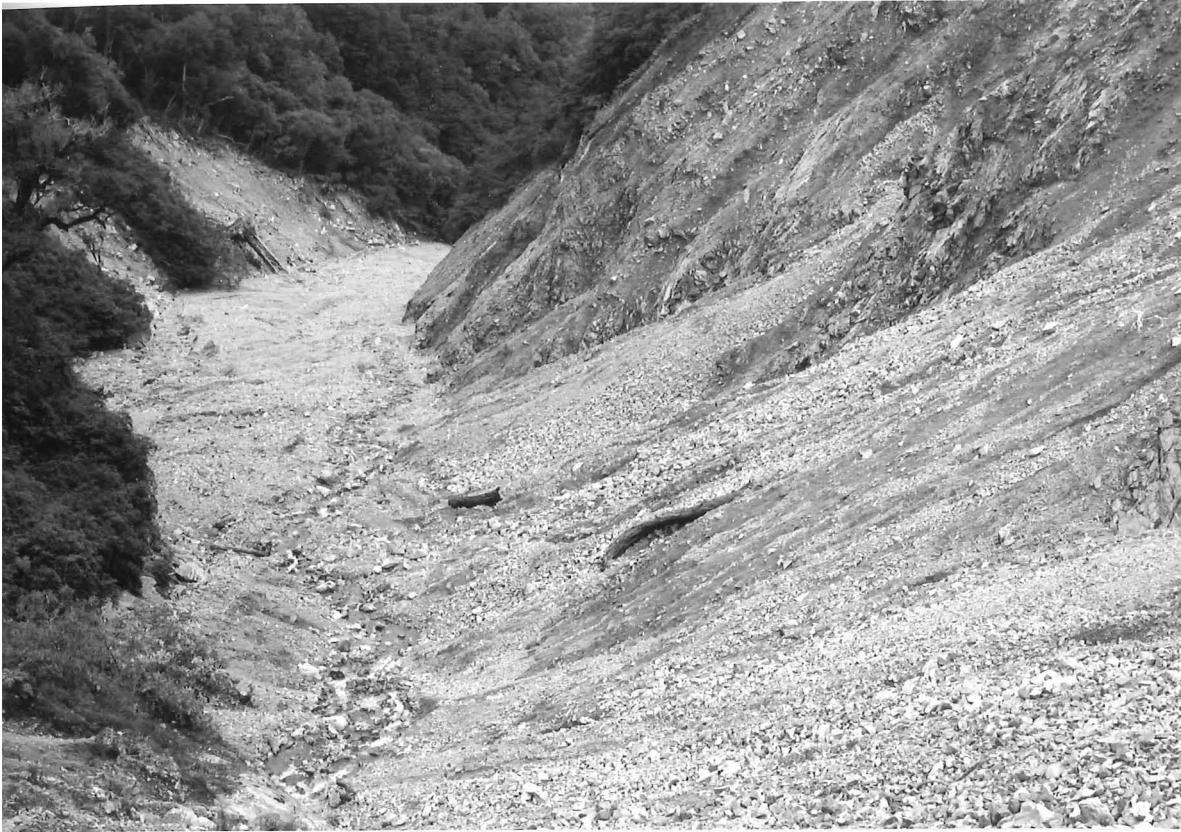
Slope storage debris passes downslope into debris accumulations (Fig. 4.8). The main difference between the two types of surficial deposits is their relative position on the slope, debris accumulations forming debris fans at the base of the slope below slope storage areas. Consequently, slope storage is the primary source of material supply to debris accumulations, usually from debris infilled gullies, but on some slopes slope movement processes directly contribute material to debris accumulations, by-passing the slope storage stage. This usually occurs where the slope is of insufficient height to store slope movement material other than at the base of the slope (Fig. 4.9).

Fig. 4.8 Debris accumulation at the base of the escarpment slope at BE 6, and rock debris alluvium overloading the streambed area; view looking downstream.

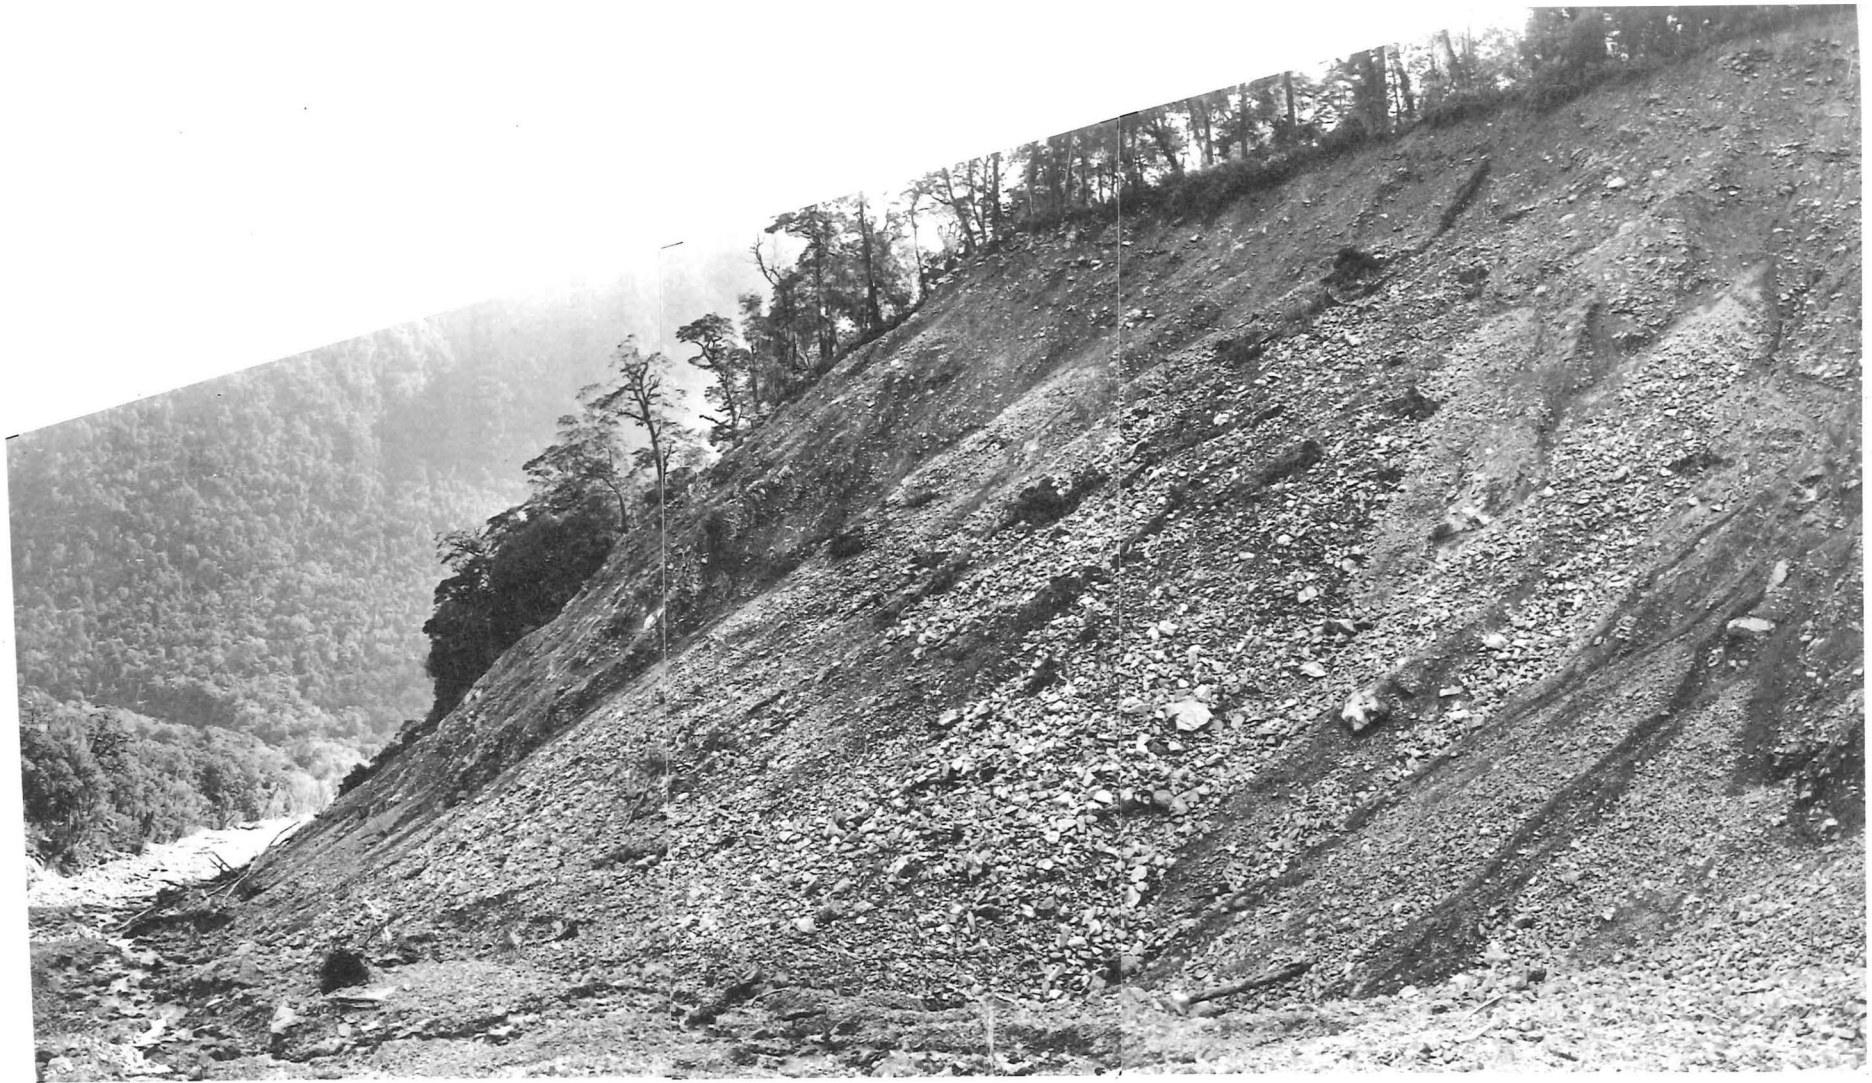
Fig. 4.9 Approx. 40m high escarpment slope at locality BE 2 covered with debris accumulations.

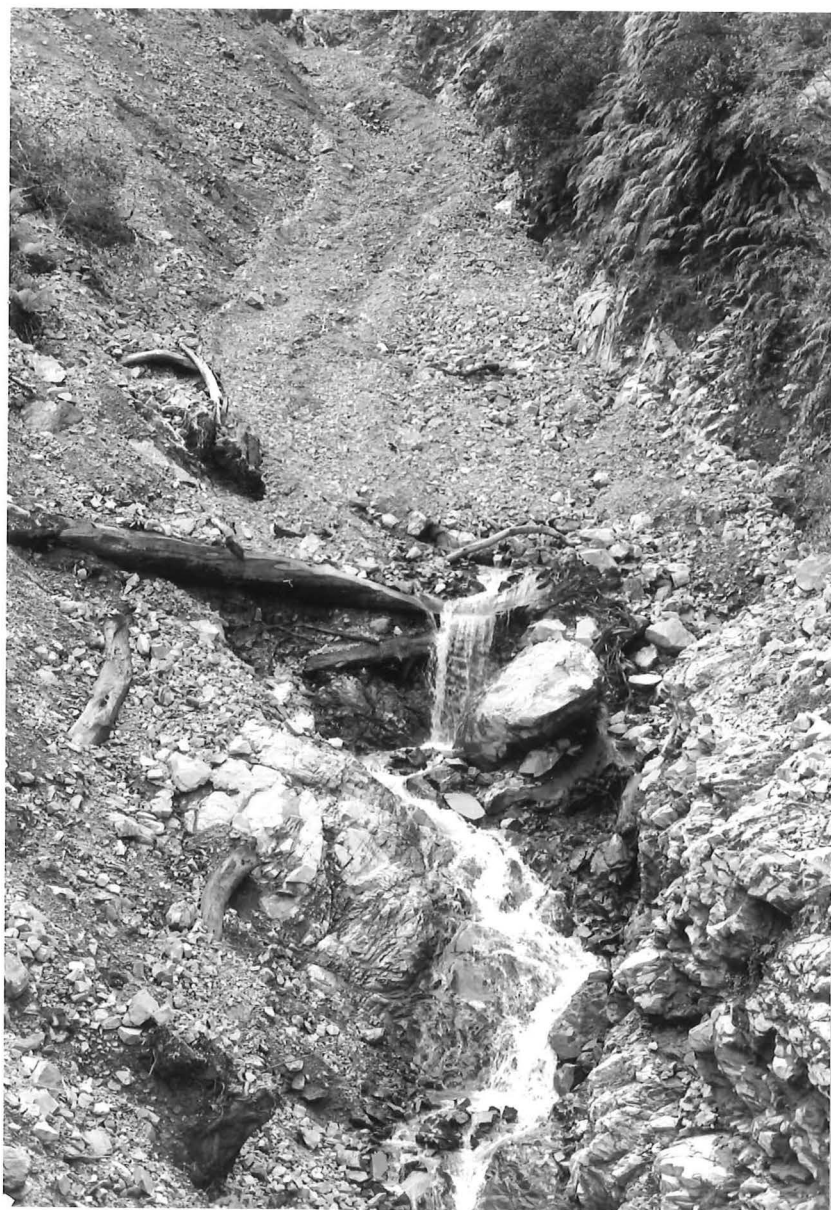
Rock debris alluvium is an alluvial fill deposit which overloads the streambed with material directly supplied from debris accumulations during phases of sediment generation (Fig. 4.10). Again there is a continuum from debris accumulation to rock debris alluvium, reflecting the change in process of origin from dominantly gravitational processes on the slopes to dominantly fluvial processes in the streambed.

Fig. 4.10 Rock debris alluvium overloading the streambed area above a 2.0m high waterfall formed by a log jam.

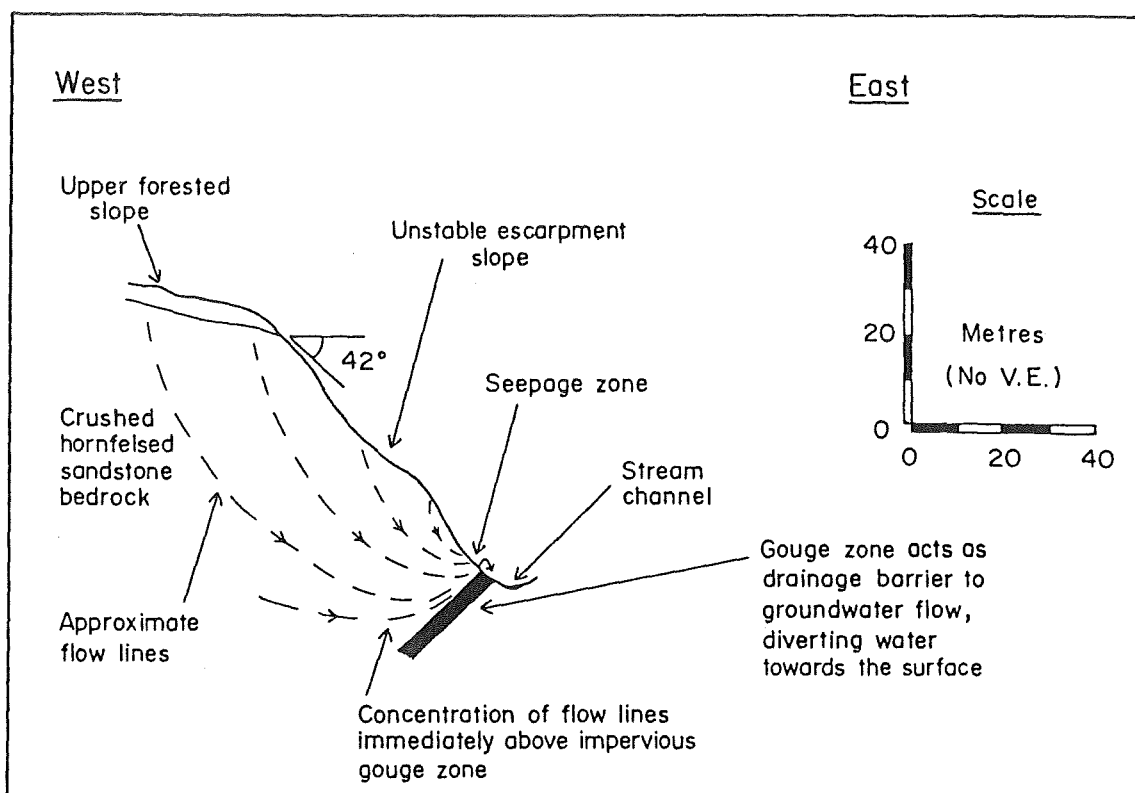
Water springs have been found to occur in association with the presence of gouge zones, particularly at BE 10, with flow rates being generally low, ranging from seepage up to approximately 100mls⁻¹. Most commonly the springs are situated immediately above the gouge zone which may indicate that the relatively impervious gouge material is creating a

Fig. 4-13 Sketch diagram illustrating the occurrence of water springs immediately above fault gouge zones in Boulder Creek

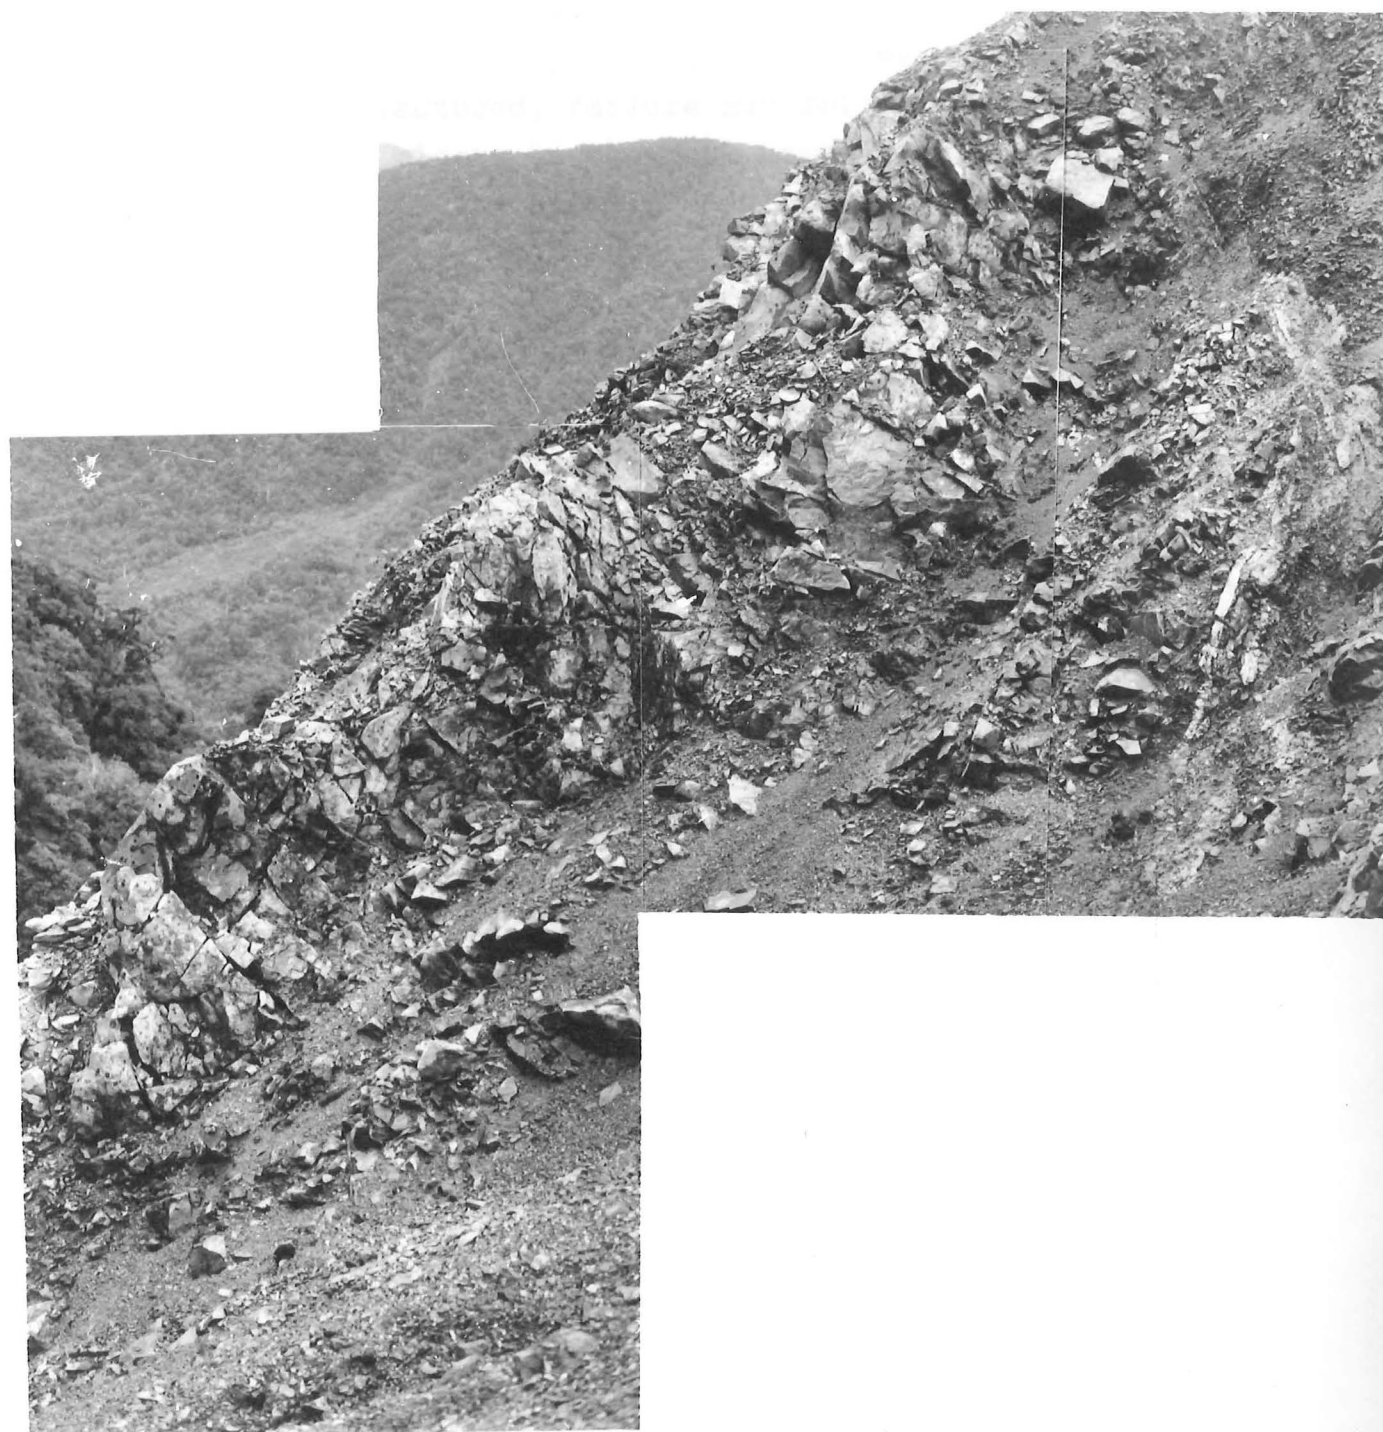
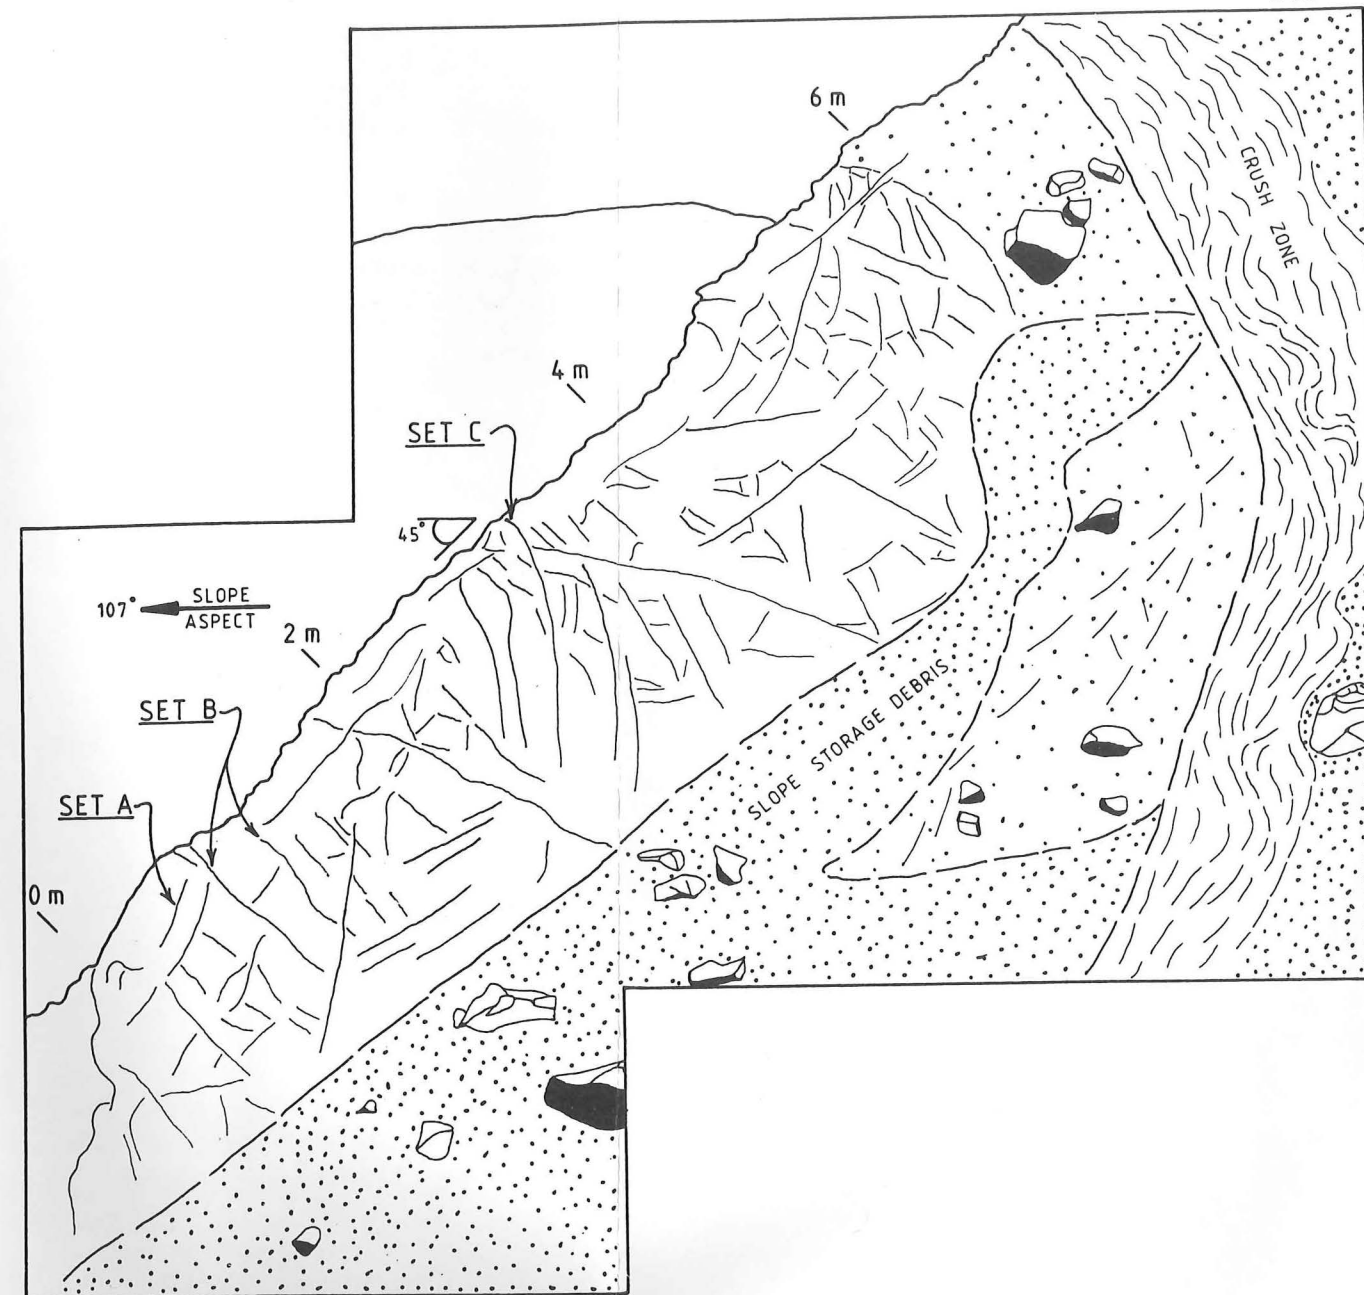
Figure 4.17 illustrates a section of the rock face at BE 2. A number of statements relating to the nature of the rock mass can be made from this face log:-

1. The top surface of the rock outcrop seems to be composed of "rock pinnacles" with debris infilling gaps in between. This may be due to extension or loosening of the rock mass near the free surface leading to toppling;
2. The upper portions of the joint defects are slightly bent downhill indicating creep (extremely slow) movement near the surface;
3. Most joint defects are open and have been infilled with sandy slope debris. This again is due to loosening of the rock mass;
4. The rock mass is of a loose nature - blocks can be pulled from outcrop by hand;

5. Joint sets B and C are parallel to the slope face, acting as release surfaces in the zone of loosening.

Steep, high slopes and the loose, crushed rock mass are the principal causes of failure. The influence of water pressure in the open joints, earthquake shaking, and ground disturbance from passing, falling blocks may act as triggering mechanisms.

Fig. 4.17 Face log illustrating crushed hornfelsed sandstone in escarpment slope at locality BE 2.

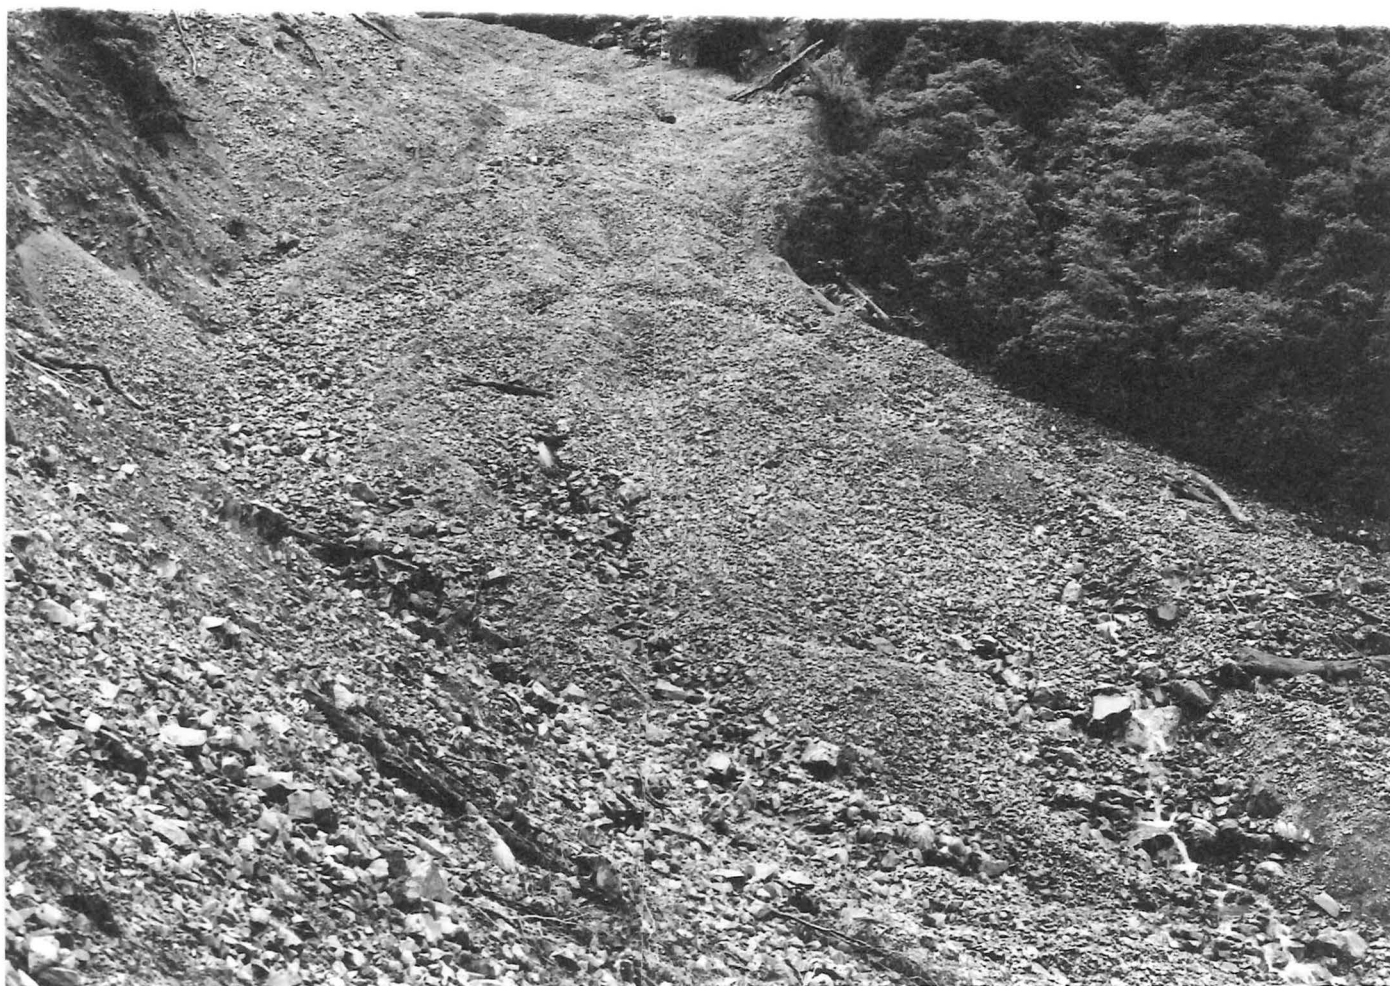
February 1986: material had moved from debris accumulation to the stream channel, forming a series of debris lobes which were moving downstream during flood events (Fig. 4.20); Table 4.5 lists the position of these lobes and correlates them to the slope area where the material originated from (the position of these lobes and of sediment "waves" which existed on the alluvial fan surface during February 1986 are given on the 1:2500 plan in Figure 2, map pocket).

Fig. 4.20 Front of debris lobe 3 (1100m position, near locality BE 2) during February 1986; note the emergence of stream flow at the base of the lobe front, and the coalescence of debris accumulations with rock debris alluvium to produce a continuous expanse of debris from hillslope to stream channel.

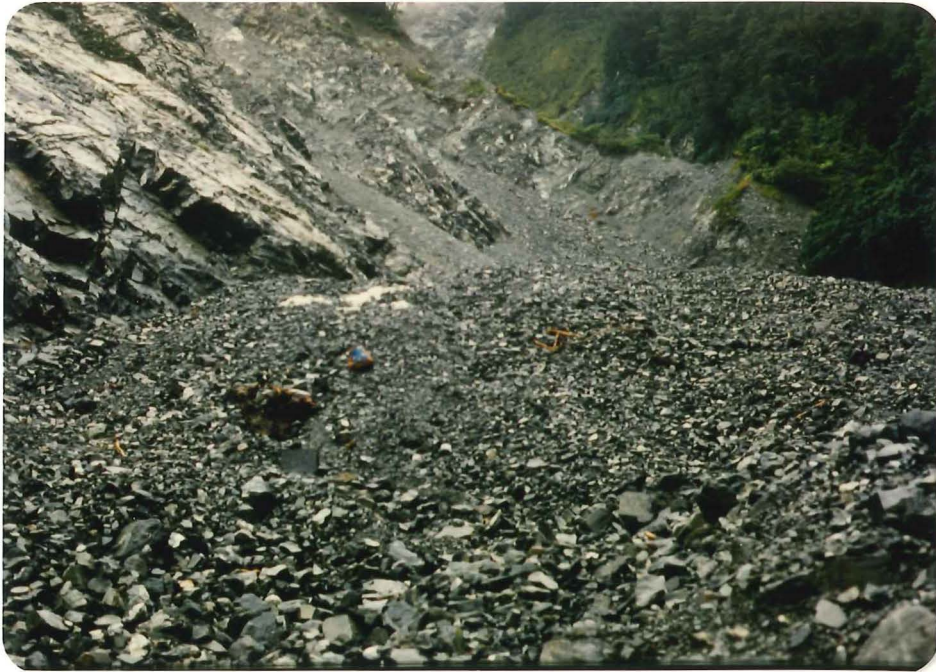
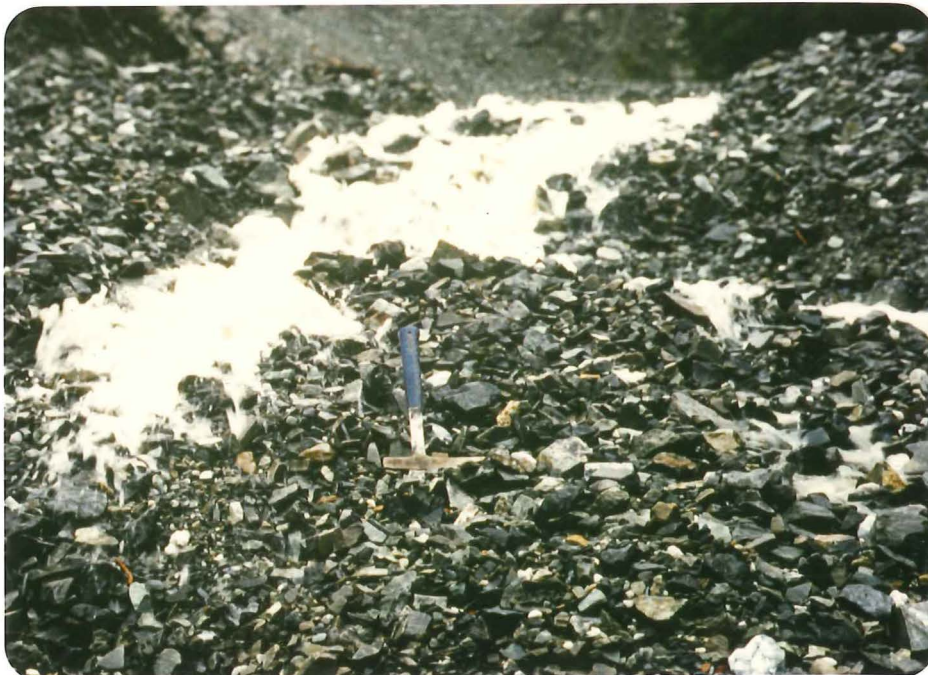
This same type of process was observed to move the rock debris lobes in Boulder Creek (Fig. 4.22 & 4.23), except that this material is coarse gravel rather than fine gravel. This implies that greater stream energy in the Boulder Creek system must be available to transport the larger bed load particle size, and this energy could be provided by the submergence of the pool-riffle channel morphology by rock debris overloading the stream channel. Modification of the steep stream gradient by a pool-riffle morphology allows the dissipation of potential energy of stream flow via a series of hydrologic jumps. If the pools are filled with debris their effectiveness in dissipating energy by turbulent mixing is impaired and flow energies increase (Hayward 1980). This increase in the capacity of the stream to do work may be sufficient to drive the mechanism to transport the coarse rock debris material.

Fig. 4.22 Rock debris lobe No. 2 at locality BE 4:
A. Oversteepened front of the debris lobe.
B. Section of the leading face transporting debris down the oversteepened front.

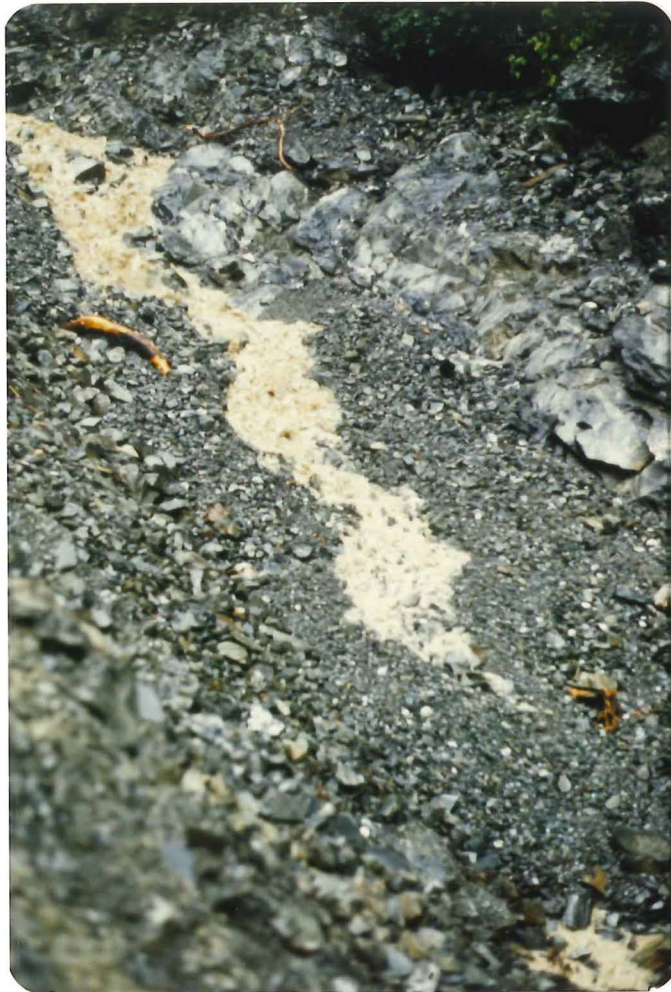
Fig. 4.23 Rock debris lobe No. 1 above locality BE 7 during high flow: transportation of debris down the leading face of the debris lobe.

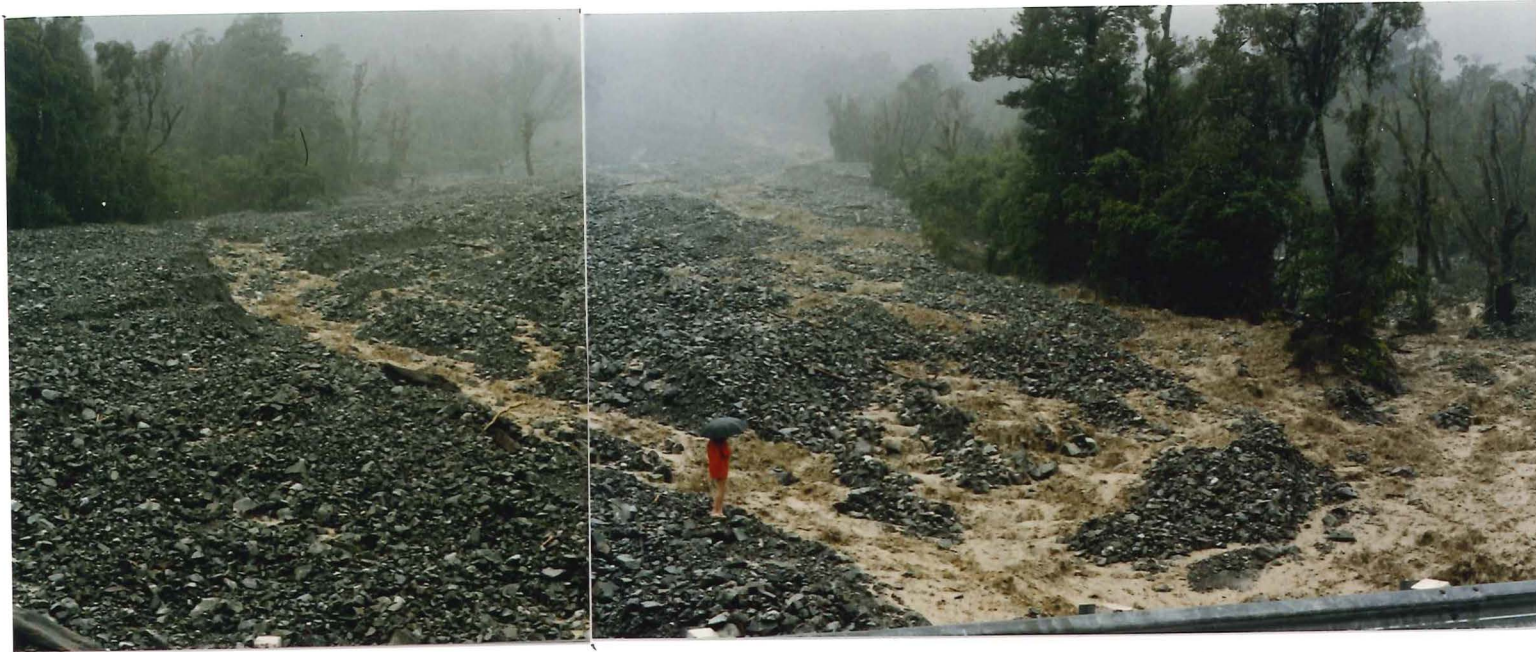
Firstly, the large amounts of sediment being transported down the fan in the form of sediment "waves" are blocking the bridge waterway opening and threaten to swamp the bridge deck. Secondly, the ability of stream channels on the fan surface to suddenly change course during high flow events (Fig. 4.24 & 4.25) is threatening the bridge road approaches. Figure 2 (map pocket) shows the direction of streamflood flows adjacent to the bridge crossing where unstable stream channels on the southeastern side of the fan are encroaching onto forest lands and cutting off the southeastern roadway approach (Fig. 4.26).

Fig. 4.24 Boulder Creek during high flow on the alluvial fan surface adjacent to the State Highway 6 bridge crossing: stream channels continually migrate across the fan surface by sudden changes in channel course, threatening the bridge road approaches.

To reduce both problems, the Ministry of Works & Development groomed the entire alluvial fan surface from the top of the fan to the bridge in October 1985, in an attempt to train the stream and direct the flow into a single straight channel down the middle of the fan surface. Apparently the main

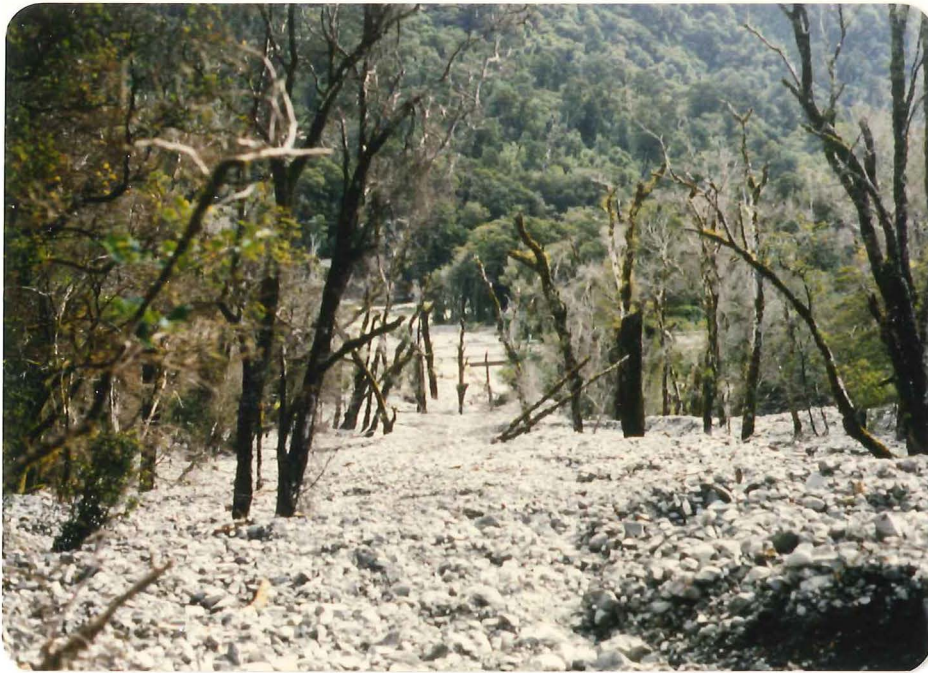
Fig. 4.25 Encroachment of alluvial fan onto adjacent forest lands depositing stream gravels beneath the forest canopy.

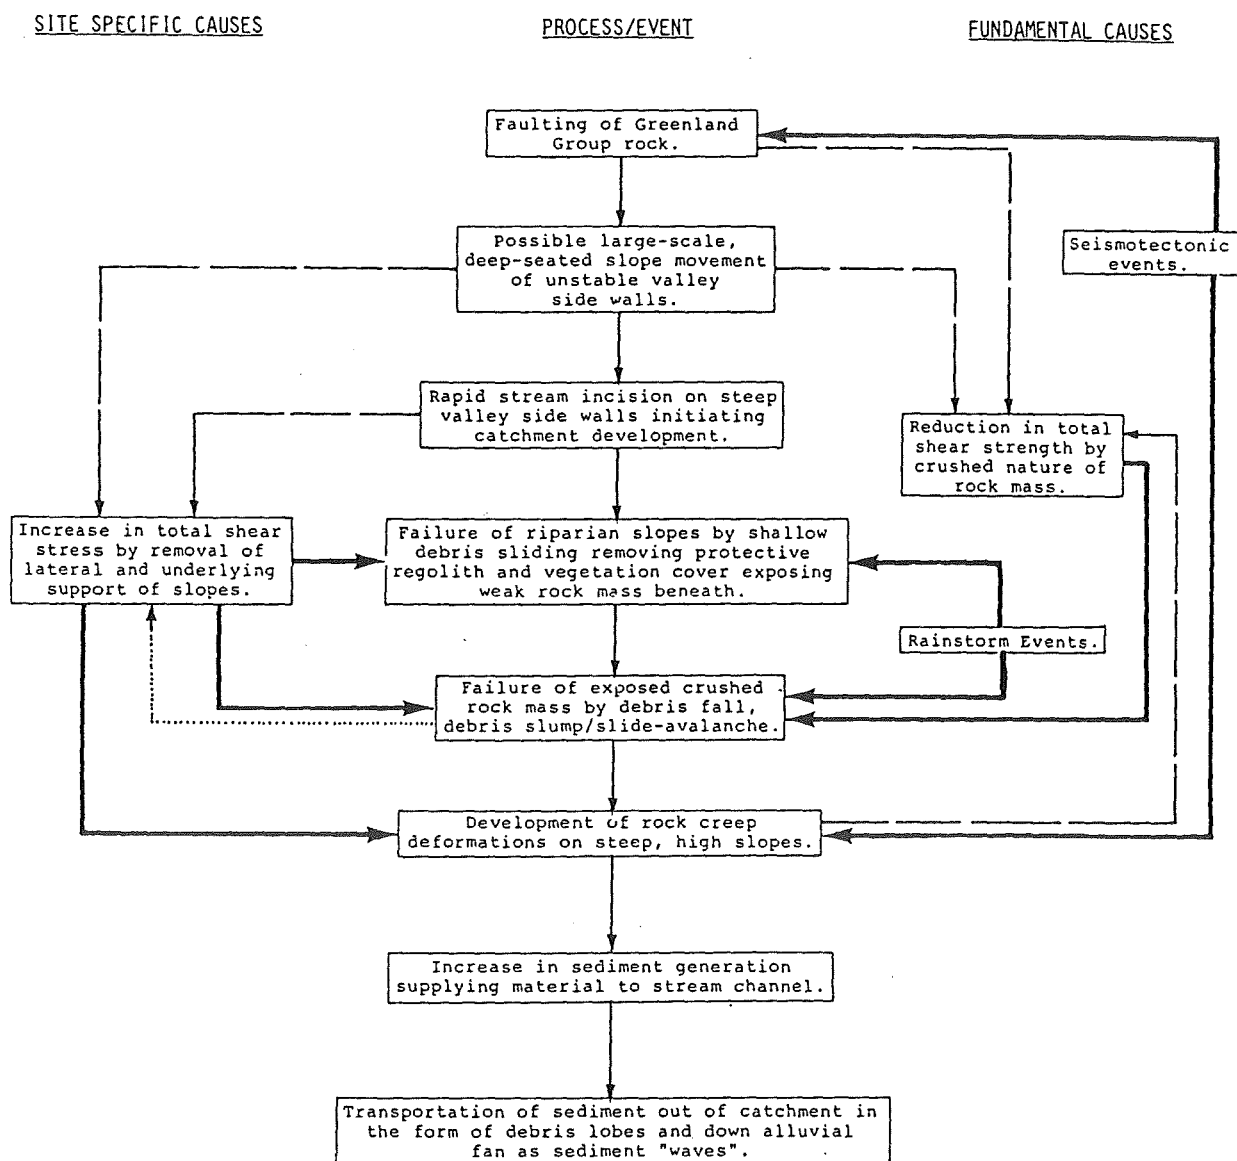
The slope evolution model interpreted for Boulder Creek, summarised in Figure 4.27, identifies a series of processes and events which have combined to form the present system of sediment generation, transportation, and deposition, and divides the causes of these processes into fundamental and site specific causes. Figure 4.28 summarises the present system of sediment movement, dividing the processes moving the sediment into gravitational and hydrologic types, and identifies four stages of sediment movement from the stream catchment to the alluvial fan: sediment generation, storage, transportation, and deposition.

1. decrease in the total shear strength by the crushed nature of the rock mass due to faulting, large-scale ancient slope movement(s), and deep rock creep;
2. increase in total shear stress by removal of lateral and underlying support due to oversteepening of slopes by ice erosion, deep stream incision, and past failure of catchment slopes (feedback loop - see Fig. 4.27);
3. high intensity rainstorm events and seismic events provide triggering mechanisms of slope failure.

Fig. 4.27 Slope Evolution Model for Boulder Creek.
